Fixing Late Model Ford Focus Engine Vibration Problems

Ford has issued a Tech Service Bulletin (TSB 11-3-24) regarding problems with engine vibration on the 2000-2011 Ford Focus. This article supersedes TSB 10-5-11 and applies to Anchor engine mount numbers 2938, 3003 and 3085.

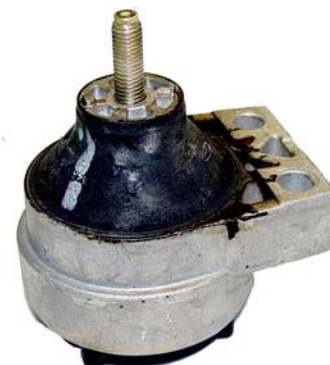
Anchor # 2938, 3003 & 3085
(difference in part numbers
is the mounting hole location)

Some 2000-2011 Focus vehicles may exhibit an excessive engine vibration which is most noticeable when the transmission is engaged in reverse. This condition may be caused by small stones, road debris, ice or snow packed/lodged in the rear engine roll restrictor.

Inspect the rear engine roll restrictor for debris and install service shield.
