PRODUCT BULLETIN

SP470200 / SP470201 – December 2009

Subject: Timken Provides OE Solution

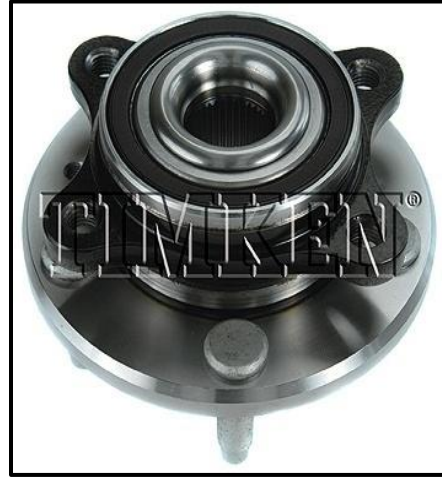
OEM Approved Without Cover

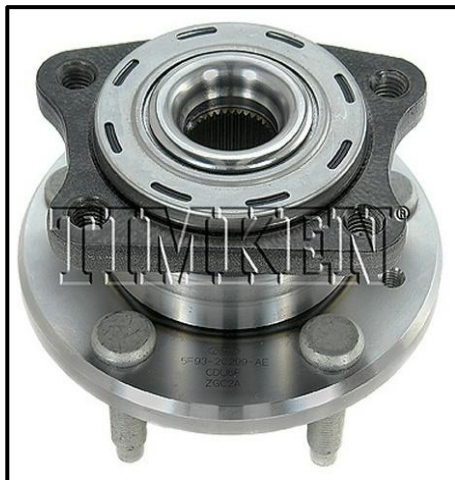
HA590029

OEM Original With Cover

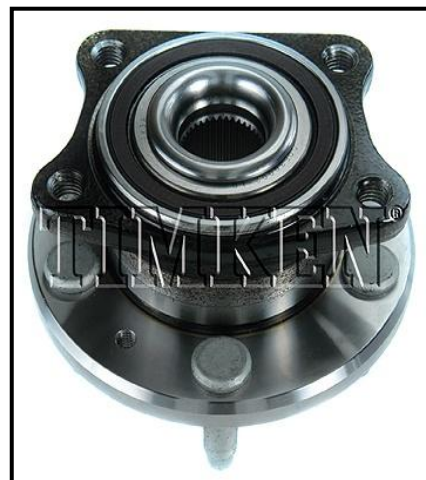
OEM Approved Without Cover

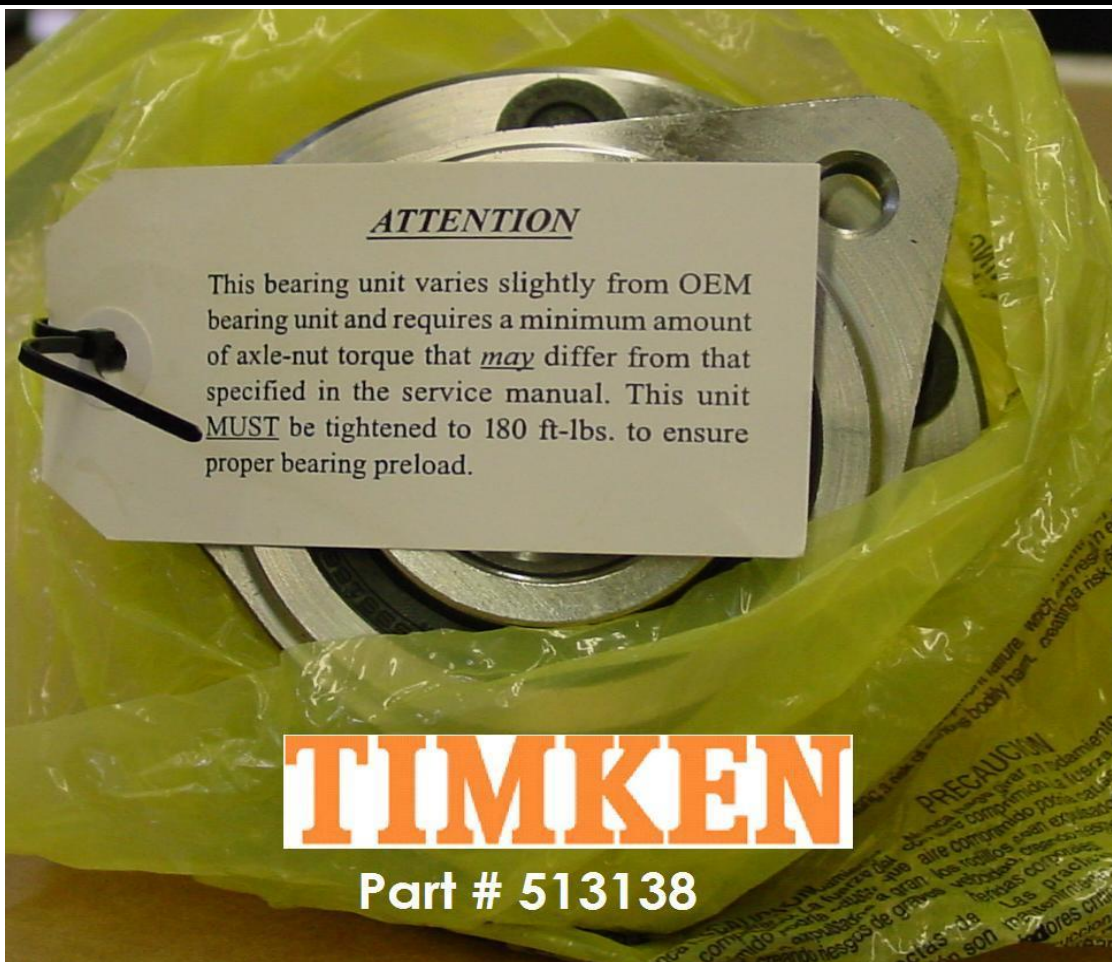
There has been an increase of warranty returns on Timken 513138 due to:

ISSUE 1: Improper Torque: The majority of units show signs of the improper torque used to set the bearing preload. Per the tag attached to the Timken units, they **REQUIRE 180 ft. lbs of torque** to properly set unit preload. Note Below: This hub fits many applications with OEM torque specs from 105-185 ft. lbs.

ISSUE 2: Improper Seating Of Axle To Hub: Sand off the rust and corrosion around the axle seating area with a fine- to medium-grade sandpaper. Take your time when doing this and make sure it's as clean as possible. Make sure the bearing assembly sits snug against axle or clamp pressure will not hold.

AXLE NUT MUST BE REPLACED TO MAINTAIN CONSISTANT CLAMP PRESSURE

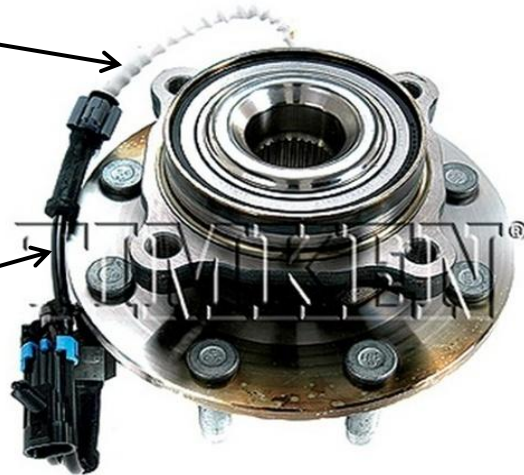
SP580310

Both hubs look exactly a like EXCEPT the earlier verison has larger size ABS Sensor Wire and White Boot coming off sensor connection.

**WHITE BOOT COVERING
COMING OFF THE SENSOR**

**LARGER DIAMETER ABS
SENSOR WIRE**

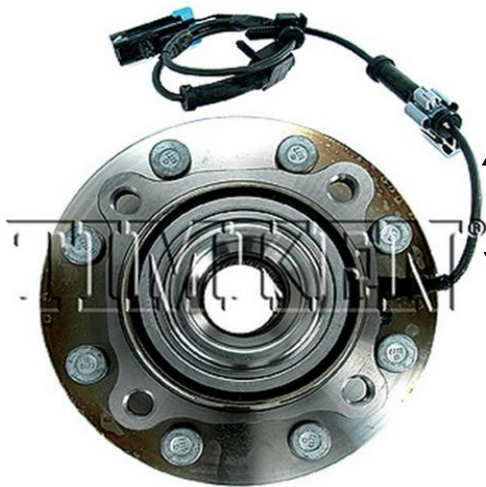
SP580312

**SMALLER DIAMETER ABS
SENSOR WIRE**

**NO ADDITIONAL COVERING
COMING OFF THE SENSOR**
